# CERAMENT<sup>®</sup>

### CASE TECHNIQUE

## Intertrochanteric Hip Fracture

**Dr. Manish Gupta, MD, FAOOS**

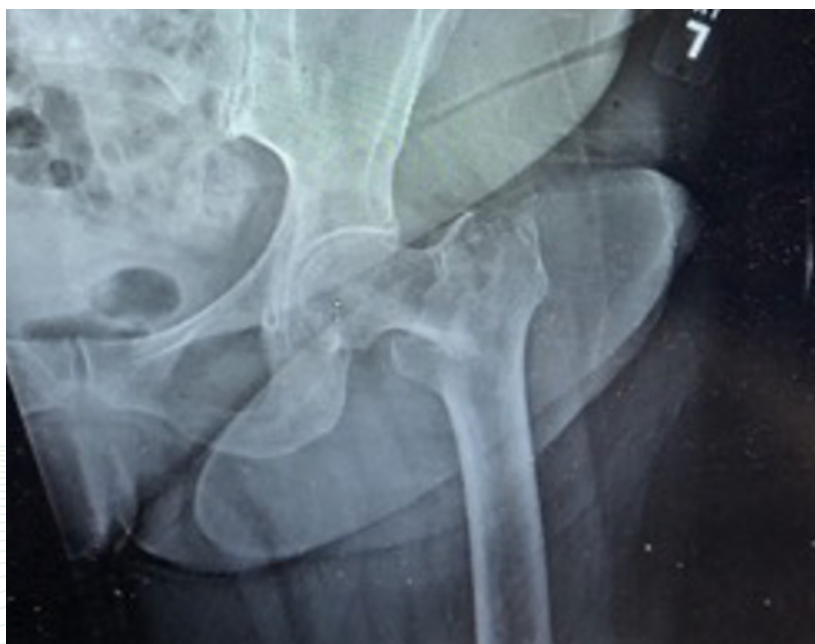
Pre-op image: X-rays show a left intertrochanteric fracture along with the femoral shaft.

A 64 year old female patient presented with a left hip intertrochanteric fracture after a fall. X-rays show a displaced left hip intertrochanteric fracture, her management plan was closed reduction and internal fixation with an intramedullary nail. She wished to proceed in order to be ambulatory and more functional.

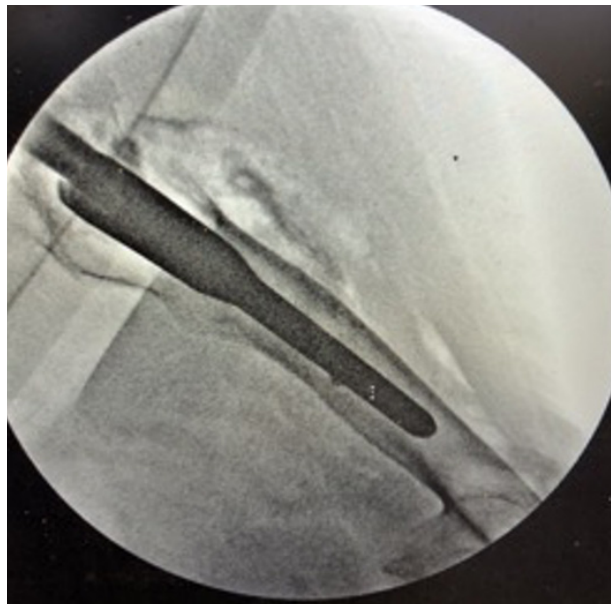
Intra-op: Case intraoperative x-rays showing intramedullary nail being placed after CERAMENT BONE VOID FILLER.

1. Closed reduction and internal fixation of left hip femoral neck fracture
2. Using the Flow-FX™ 2-CAN®, a 450mm double-cannulated side-port delivery system with a radiopaque tip, CERAMENT® BONE VOID FILLER was precisely delivered into the reamed canal over the guide wire under fluoroscopic guidance.

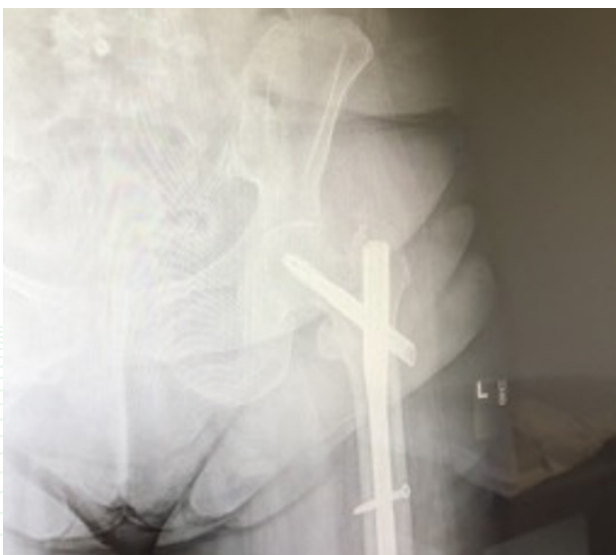
Post- op: Six-month follow-up post-operative x-ray.

At 6 months, the patient denies any pain in the affected limb (VAS: 0/10), and denies regular analgesic use. Clinical examination demonstrated full hip ROM without tenderness, swelling, or deformity. Range of motion is unremarkable and there is no gross instability, while maintaining normal strength and tone of the thigh and calf muscles. Radiographs (AP pelvis, AP hip, and lateral frog-leg views) confirmed complete fracture union with well-maintained implant alignment and no evidence of complications.

Serial imaging demonstrated consistent fracture healing, with bridging callus evident by 3 months and complete union by 6 months.

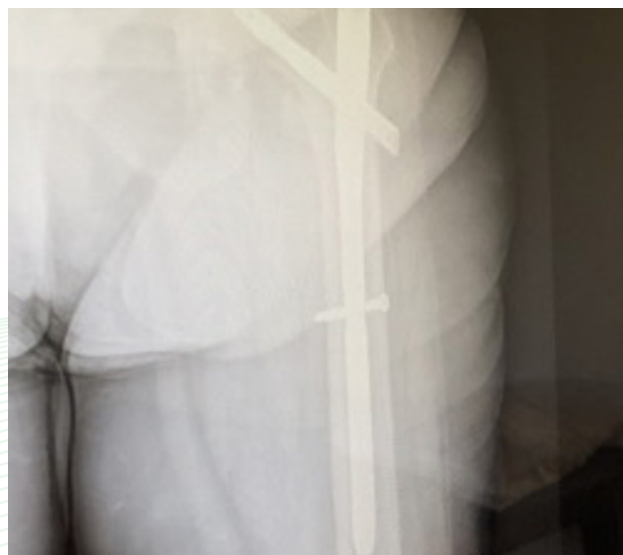
Post- op: Six-month follow-up post-operative x-ray illustrating the entire intramedullary nail.
