CASE REPORT

CERAMENT V in a Two-Stage Infected Knee Revision

Dr P. Bergh, Dr C. Berger and Dr S. S. Eriksson, Sweden

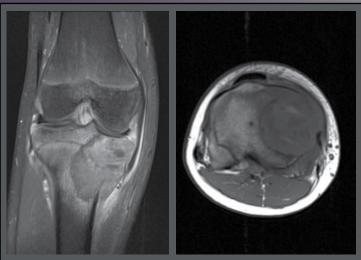
Figure 1.

The patient had an osteosarcoma in the proximal tibia (Fig. 1), a course of chemotherapy (Fig. 2) and implantation of a hinged knee prosthesis (Fig. 3). This became infected and a two-stage arthrodesis was carried out.

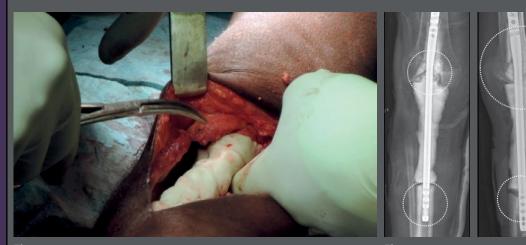
Figure 6.

- In the first stage, the knee implant was removed and a resection and thorough débridement of all infected and dead tissue was carried out.
- The medullary canals were brushed and flushed with saline and a 30-35 cm long metal rod was inserted from the femoral medullary canal into the tibial medullary canal (Fig. 4).
- CERAMENT V was injected around the rod and into any cavities in both the femur and tibia (Fig. 5), to provide a high dose of local antibiotic and improve bone stock for the second stage procedure.
- To preserve leg length and for load-bearing, PMMA was shaped and placed around the metal rod and between the femoral and tibial bone ends (seen on Figs. 6, 7).
- Four months later the second stage was carried out and the metal rod was replaced with an uncemented arthrodesis nail (Figs. 8, 9).

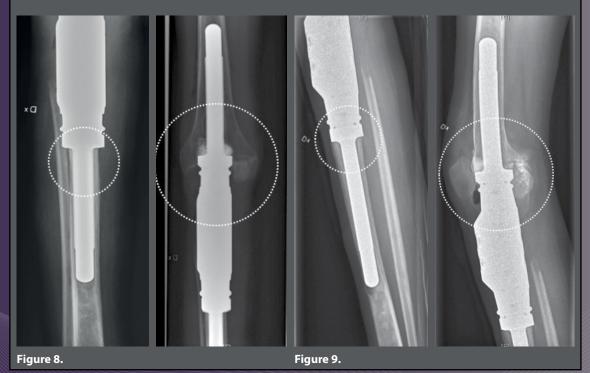
- Immediately post-operatively CERAMENT V is clearly visible at the distal femur and proximal tibia (shown by the white circles in Fig. 7).
- An x-ray following the second stage procedure four months later shows bone remodeling in all areas where CERAMENT V has been injected (shown by the white circles in Figs. 8, 9).
