CERAMENT® BONE VOID FILLER

Management of a Calcaneal Non-Union and Sub-Talar Joint Arthrodesis from a Calcaneal Fracture with Arthrodesis with CERAMENT BONE VOID FILLER

J. C. Karr, DPM, USA

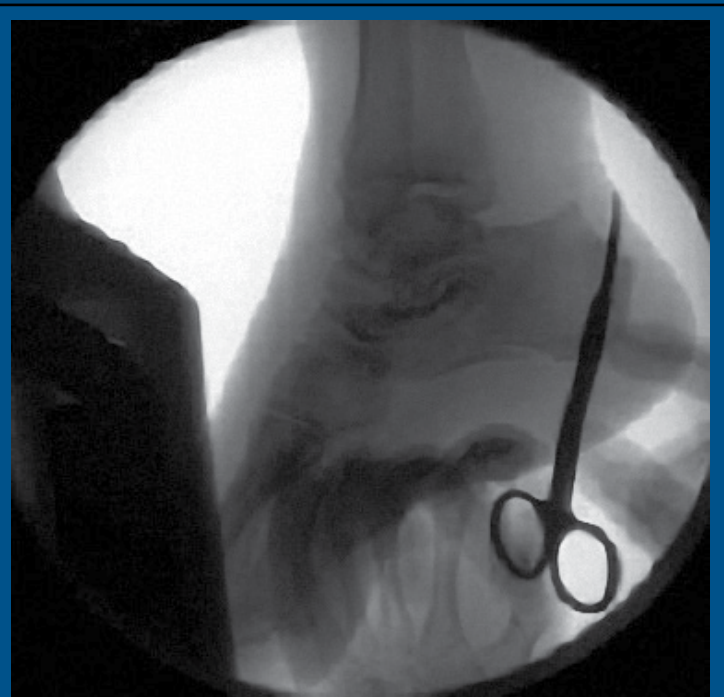
Figure 1. Initial lateral imaging of the fracture.

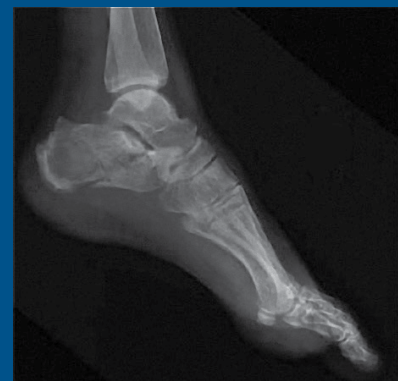
Figure 5. Foot radiograph of the non-union.

This increased pain was unresponsive to continued physical therapy, arthrocentesis, and NSAID therapy. Radiograph and CT evaluation revealed a significant calcaneal fracture non-union and sub-talar joint arthrodesis. A bone stimulator was used for eight weeks without clinical improvement. The patient continued to smoke during the entire treatment process.

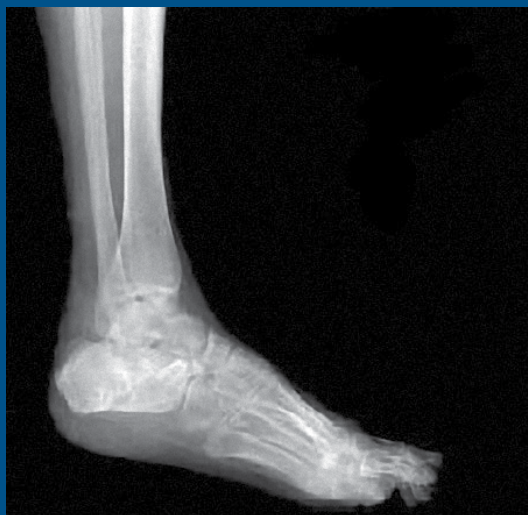
Figure 7. Final post-operative radiograph.

The patient had an unremarkable post-operative course. The external fixator was removed at eight weeks with initiation of physical therapy. The patient progressed well with consolidation of the calcaneal non-union and the sub-talar joint arthrodesis.
