Case Report

Treatment of an
osteoporotic proximal humerus fracture
with **CERAMENT®**|BONE VOID FILLER:
12 month follow-up

DR. M. VAN DER ELST
Reinier de Graaf Hospital, Delft, The Netherlands

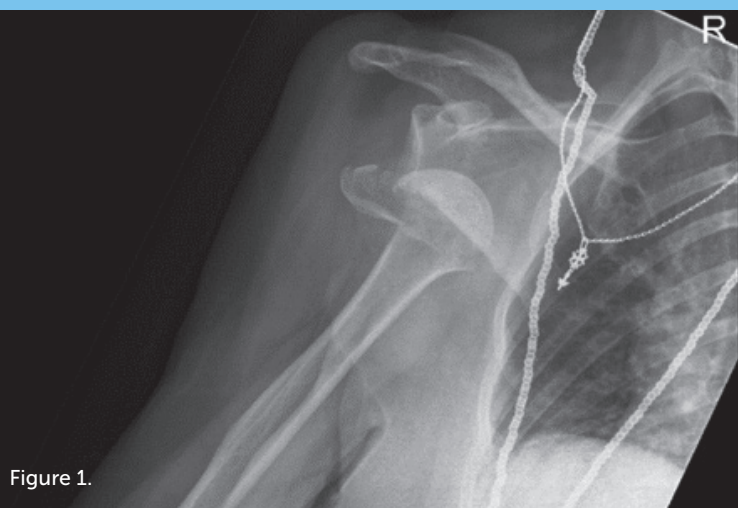
Figure 1.

➡ Proximal humerus fracture-dislocation (AO Type 11-C) as a result of a fall from a bike (Figs. 1 & 2).
