Medical Education Series

Treatment of an Osteoporotic Proximal Humerus Fracture

BONE VOID FILLER

OSTEOPOROTIC PROXIMAL HUMERUS FRACTURE

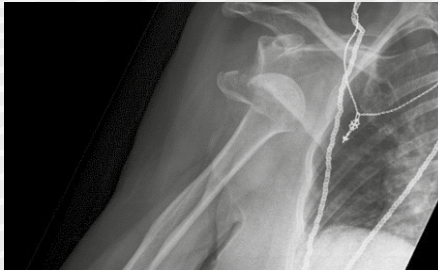
Figure 1.

62 year old with established osteoporosis. Proximal humerus fracture- dislocation (AO Type 11-C) as a result of a fall from a bike (Figs. 1, 2).

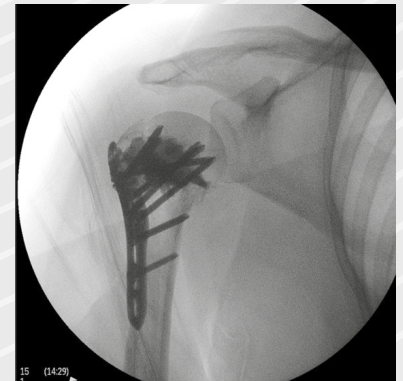
Figure 3.

The bony defect was filled with 6cc CERAMENT BONE VOID FILLER (BVF) under continuous fluoroscopy (Fig. 3) and allowed to set for 15 minutes.

The fracture was reduced and fixed using a Philos plate (Synthes®) and the cuff was attached to the plate using non-resorbable sutures (Ticron®).

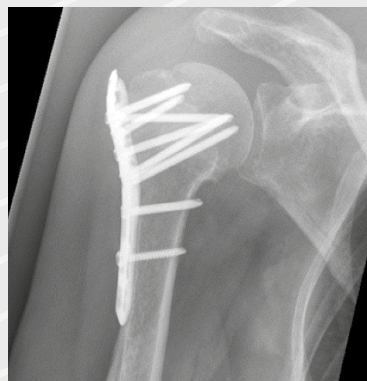
Figure 4.

X-rays at 12 months post-op demonstrate fracture healing and remodeling of CERAMENT BVF into trabecular bone (Figs. 4, 5).
