CERAMENT® BONE VOID FILLER

Treatment of a Proximal Humerus Fracture with CERAMENT BONE VOID FILLER

Dr. M. Van Der Elst, The Netherlands

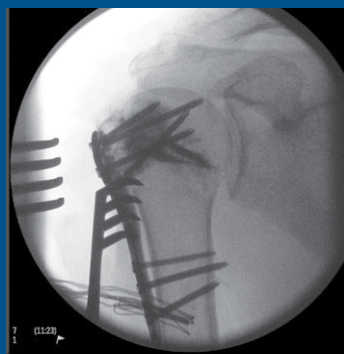
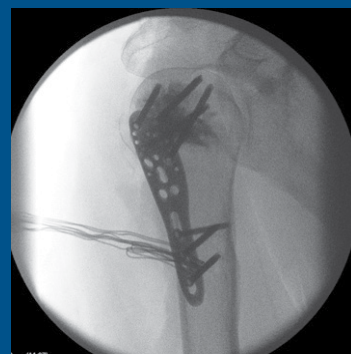
- The fracture was reduced and fixed using a Philos plate (Synthes®) and the cuff was attached to the plate using nonabsorbable sutures (Ticron®).
- The bony defect was filled with 6cc CERAMENT BONE VOID FILLER under continuous fluoroscopy (Figs. 3, 4) and allowed to set for 15 minutes.

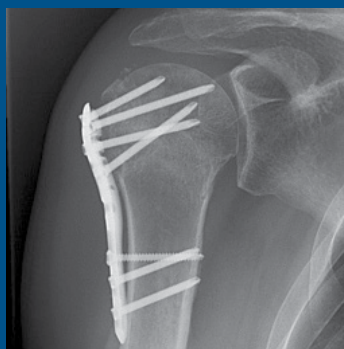
- The fracture healed uneventfully. The patient recovered good range of motion:
 - abduction: 100°
 - flexion: 100°
 - external rotation: 45°
 - internal rotation: 45°
- X-rays at 12 months post-op demonstrate fracture healing with remodeling of CERAMENT BONE VOID FILLER into trabecular bone (Figs. 5, 6).
