Medical Education Series

# Osteochondral Lesion of the Talus

Mihir M. Patel, MD

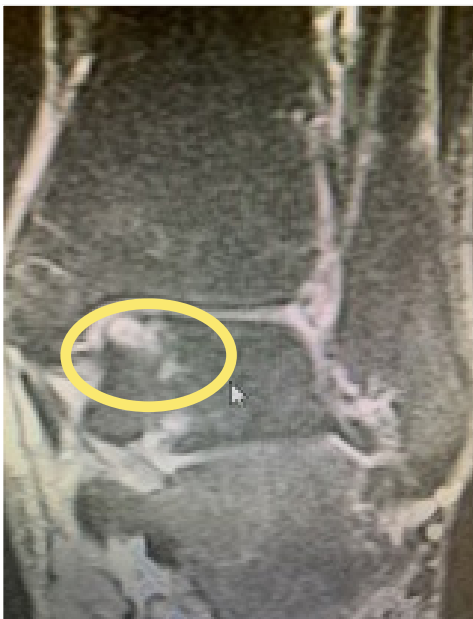
**Figure 1.** T2 MRI Image of OCD Lesion

52 year old patient was diagnosed with symptomatic osteochondral lesion of the Talus.

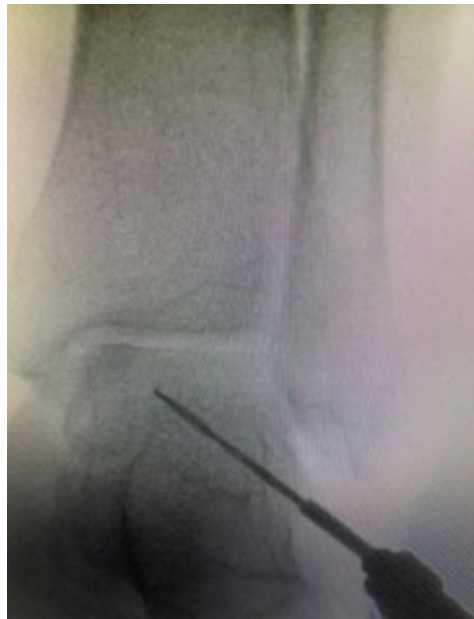
**Figure 2.** Retrograde drilling of the OCD Lesion

- The overlying cartilage was intact, so the patient underwent retrograde drilling of the OCD lesion, core decompression, and filling of the bone marrow lesion and drill track with 1.5cc of CERAMENT BONE VOID FILLER.
- The goal of CERAMENT was to fill the bone voids and allow for the remodeling of bone.

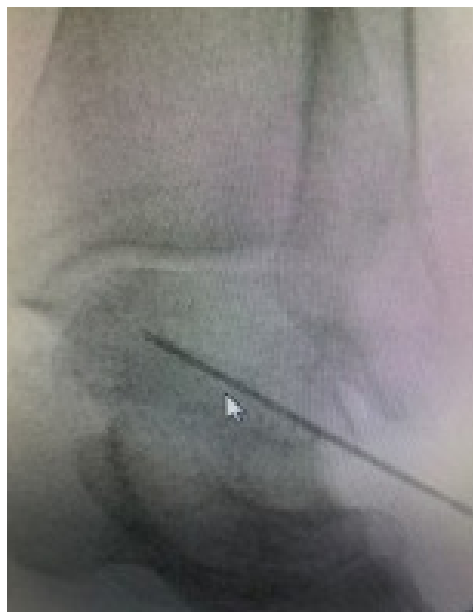
**Figure 3.** Voids at lesion and drill track are filled with CERAMENT

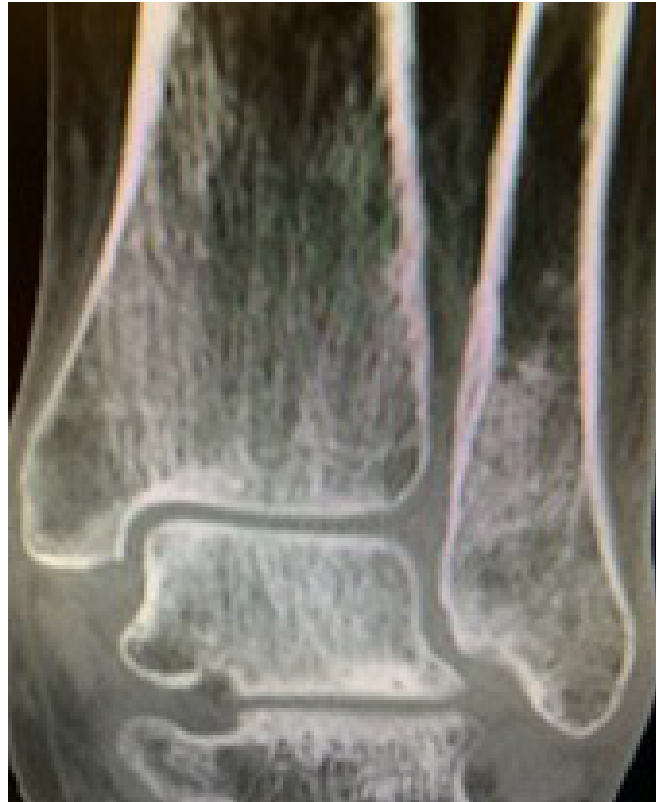
**Figure 5.** CT Scan at 4 months post-op

Post-operative CT scans showed the bone graft incorporating into the talus and bone remodeling where CERAMENT had been injected.
