# Proximal Humerus Fracture

# CERAMENT<sup>®</sup>

## Proximal Humerus Fracture

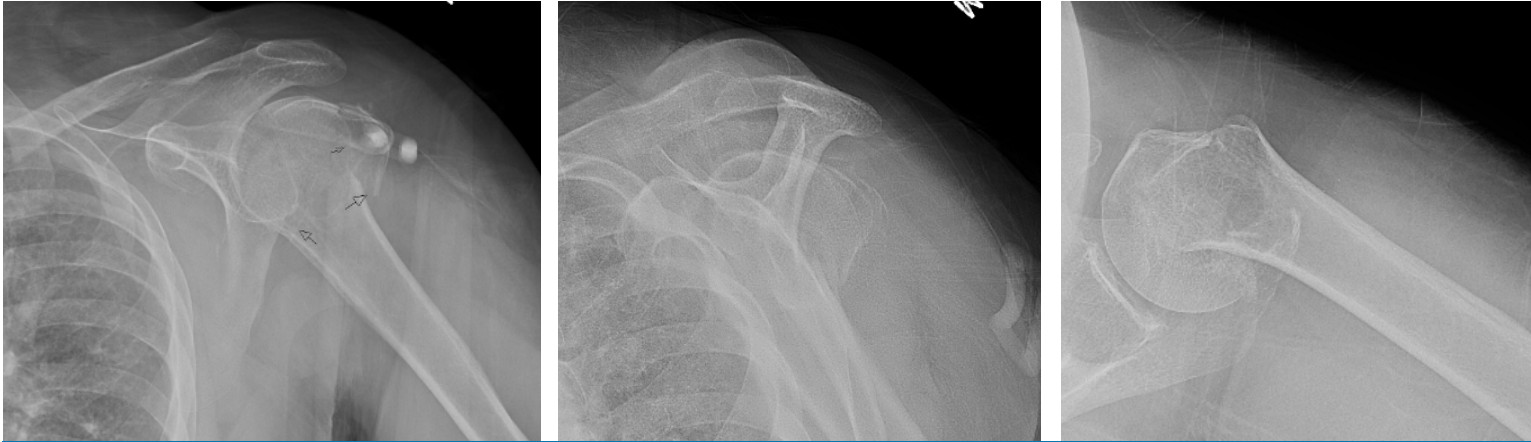
Pre Op

A 60 year old female presented with a three part proximal humerus fracture after slipping on an icy road.

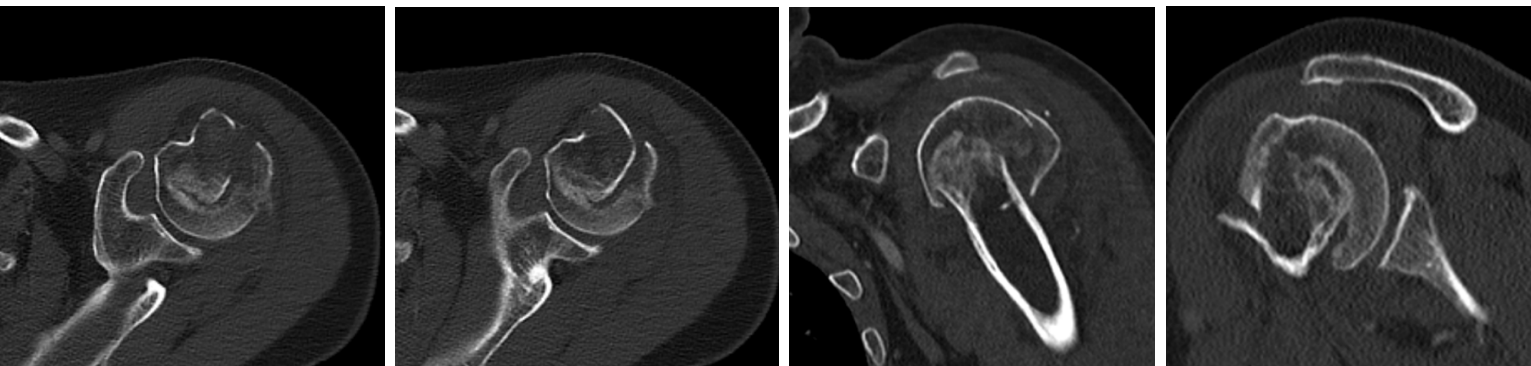
CT scan: Impaction at the fracture site

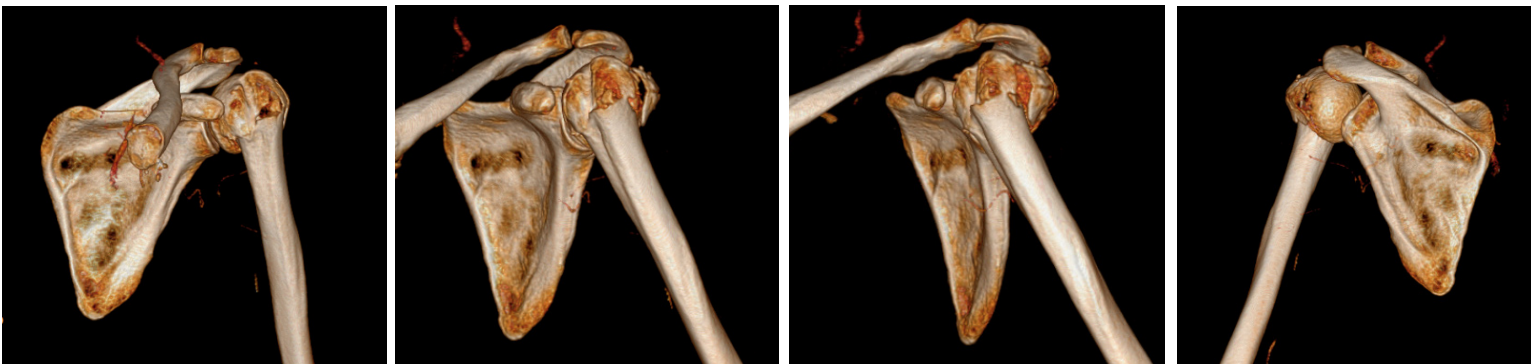
3 part proximal humerus fracture

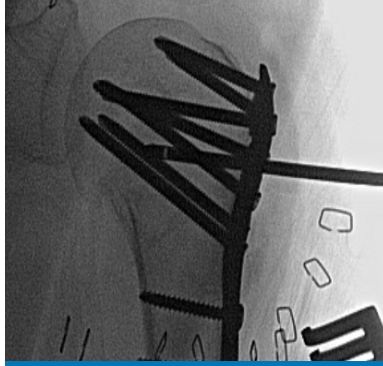
Intra-Op: Shows insertion of 11 gauge cannula through a screw hole in the plate and into the central void

- Fracture reduction which results in significant bone void at the fracture site. This can lead to secondary loss of fixation and fracture settling if the void is not filled.
- Unfortunately, once most fractures are reduced access to the bone void becomes limited.
- Access to the central portion of the bone void was obtained using an 11 gauge drillable cannula to inject 10mL of CERAMENT.

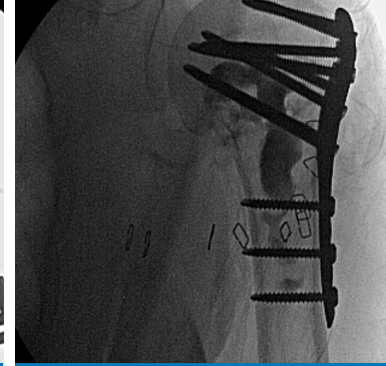
Immediate Post-Op: Shows where CERAMENT has been injected

CERAMENT's radio visibility and flowability provided excellent fill throughout the void. This provided the option for minimally invasive fill of a bone defect that is not possible with traditional bone grafts.

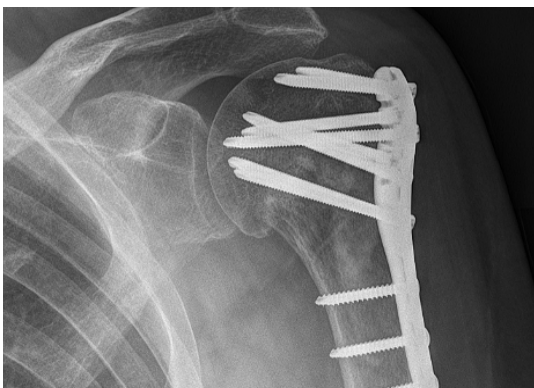
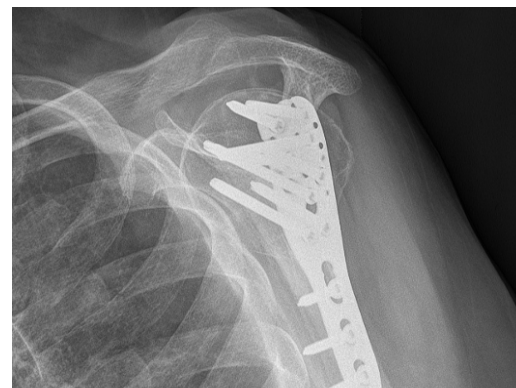
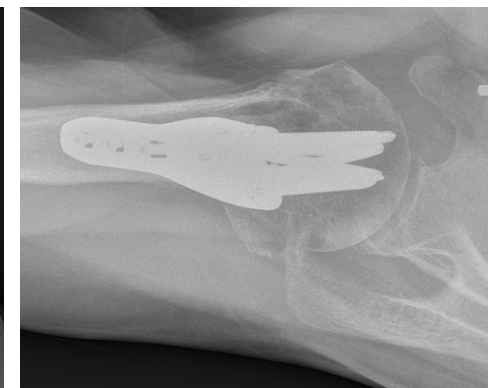
PostOp: 3 months

At 3 months post-op, resorption and remodeling of CERAMENT into bone is apparent. The fracture is healed and the patient has excellent painfree use and function of arm.
