# CERAMENT<sup>®</sup> V

## Arthrodesis Supplemented by CERAMENT V as a Salvage Procedure in FRI with Destruction of the Tarsometatarsal Joints

Dr. M. Velickovic  
Germany

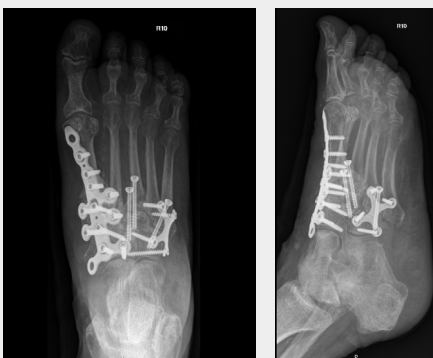
Figure 1.

- A complete arthrodesis of the tarsometatarsal joints was performed with a medial column plate (Arthrex, Inc., Naples, FL, USA) and laterally with a 3.0mm Titanium X-plate (Arthrex, Inc.); and an additional 4.0mm cannulated lag screw (DePuy Synthes, Inc., West Chester, PA, USA). For fixation of metatarsal III, two 4.0mm cannulated lag screws (DePuy Synthes, Inc.) were used (Figure 1).

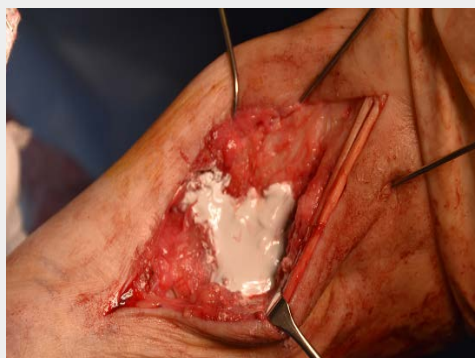
Figure 2.

- The Lisfranc joint row was filled with 6ml of CERAMENT V, and primary wound closure was performed (Figure 2).
- Intraoperative microbiological samples did not grow any organisms, and histology showed an inflammatory reaction. The patient was intravenously administered Clindamycin 600mg three times a day for two weeks in our in-patient clinic, followed by two weeks of oral administration of Clindamycin after hospital discharge.

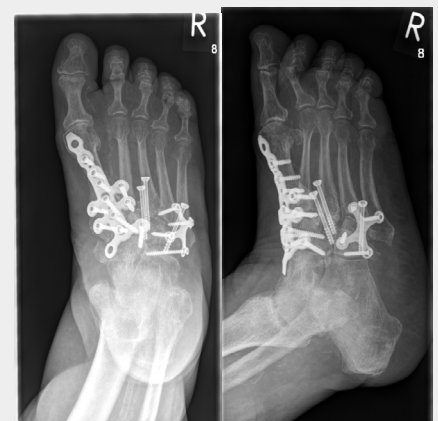
Figure 3.

- With the help of a forefoot offloading shoe, the patient was mobilized to full weight-bearing on crutches after the second postoperative day.
- Radiographs at 3.5 months showed progressing consolidation of the arthrodesis (Figure 3).

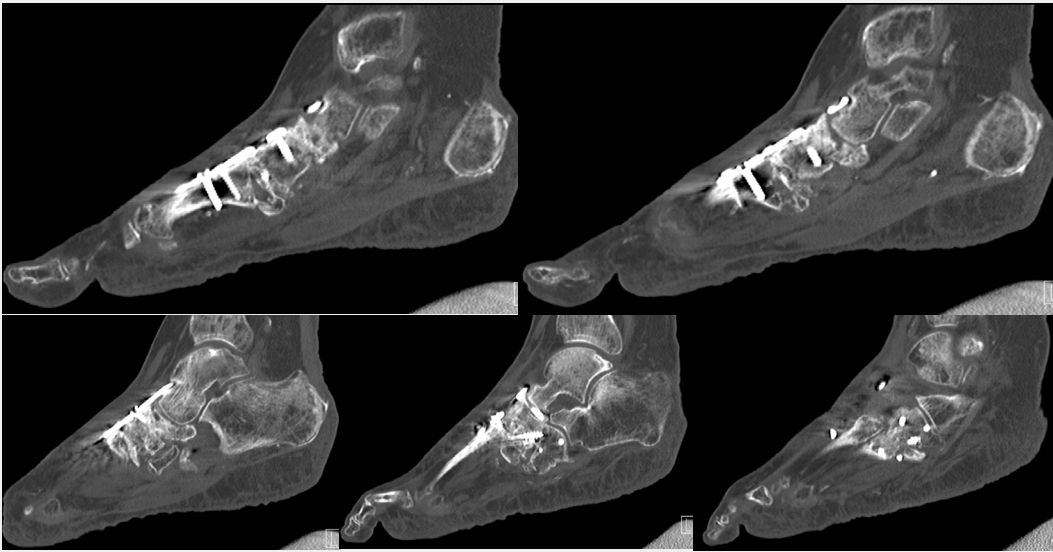
Figure 4.

- The patient did not report any complications and showed no signs of wound healing problems or inflammation.
- At final follow-up, 11 months after the arthrodesis, the patient was mobile on forearm crutches and was able to climb stairs. She reported slight foot pain but no hypersensitivity. The soft tissue envelope had completely healed, laboratory infection parameters were within physiological range and the patient was infection-free. No adverse events had occurred during the follow-up period. CT scans showed complete osseous consolidation of the arthrodesis in all views (Figure 4: sagittal view, various layers; Figure 5: axial view, various layers; and Figure 6: coronal view, various layers).
