CERAMENT® BONE VOID FILLER

Re-revision of a Failed THA Revision Using CERAMENT BONE VOID FILLER

A. J. Wassef, MD, USA

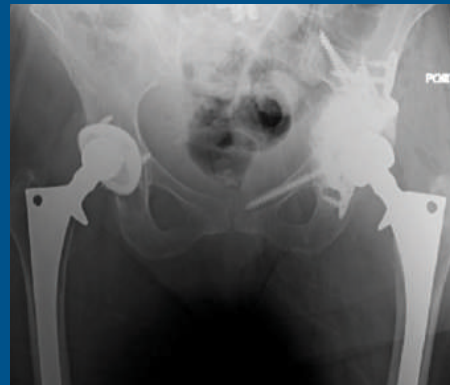
Intra-op.

Complete anterior column deficiency and pelvic discontinuity. Placed pelvic cage for structural support and completely backfilled the absent medial wall with CERAMENT.

- Complex revision left THA with acetabular bone grafting using CERAMENT BONE VOID FILLER to reconstitute the medial wall.
- Pelvic cage reconstruction for structural support and CERAMENT BONE VOID FILLER for bone grafting.

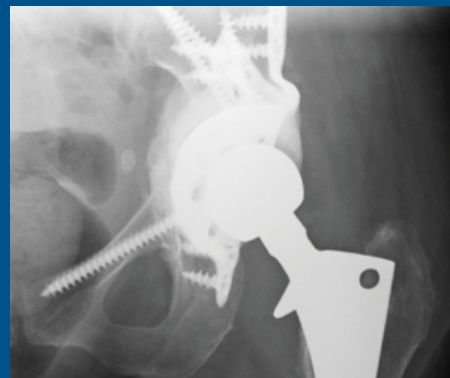
2 Month follow up.

CERAMENT is clearly visible.
