CASE REPORT

Complex Pelvic Triflange Revision

CERAMENT[®] BONE VOID FILLER

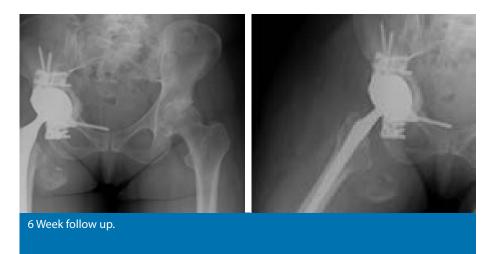
Pre-op: Radiographs show failed revision with progressive protrusion of acetabular component.

- Primary metal-on-metal (MOM) THA approximately 12 years prior.
- Revision performed by OrthopedicSurgery Specialist (OSS).
- Severe osteolysis with pelvic discontinuity, revision cup with femoral head allograft used.
- Pre-op radiographs show failed revision with progressive protrusion of acetabular component (result of a previous surgery).

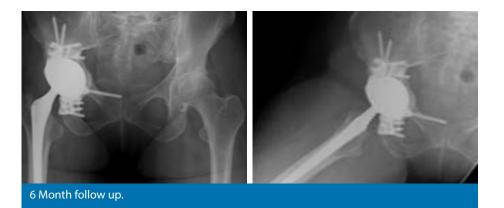
Post-op.

Complex pelvic triflanger revision with structural support and use of CERAMENT[®] BONE VOID FILLER for reconstitution of medial bone stock.

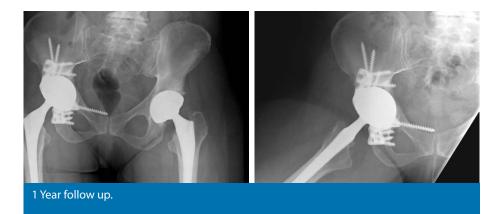
FOLLOW UP RADIOGRAPHS

At 1 year follow up shows good bone formation and patient is pain free and doing well.
