Medical Education Series

# Open Fracture of the Forefoot

**Dr. J. Palmer Branch, DPM**  
*Comprehensive Foot & Ankle, LLC*  
*Cumming, GA*

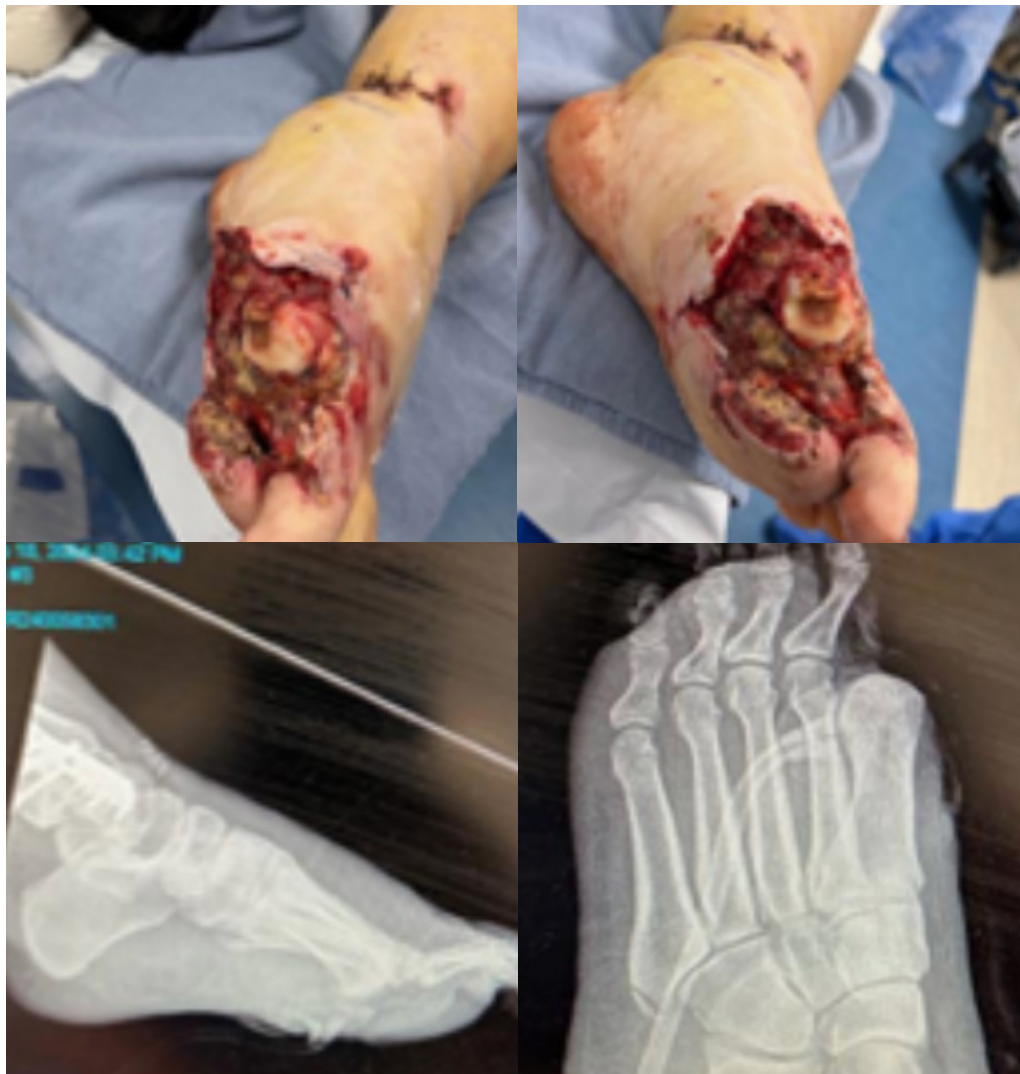
The wound was inspected at the time of the revision surgical debridement and grafting. Exposed bone (1st metatarsal) and nonviable skin were noted. Pre-op x-rays show a traumatic amputation of the 1st metatarsal.

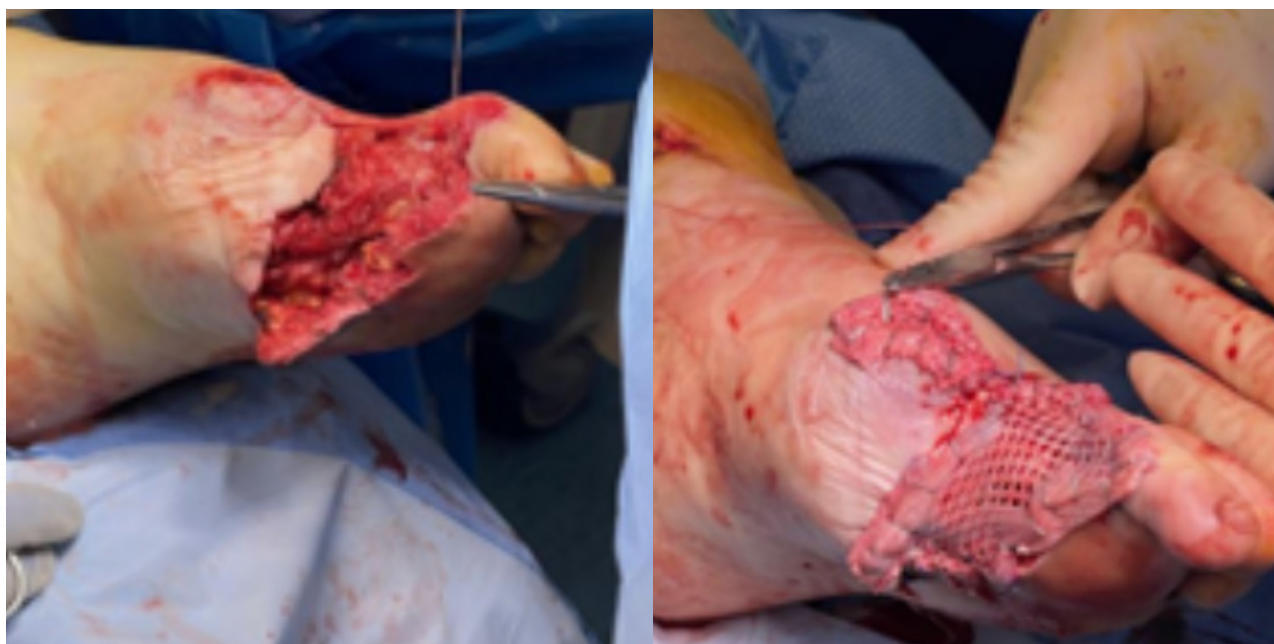
The wound was debrided and the available skin and soft tissue were used to reduce the wound size. This provided some bone coverage of the end of the 1st metatarsal remainder. CERAMENT G was injected in the 1st metatarsal. A meshed dermis graft was applied over the wound for coverage.

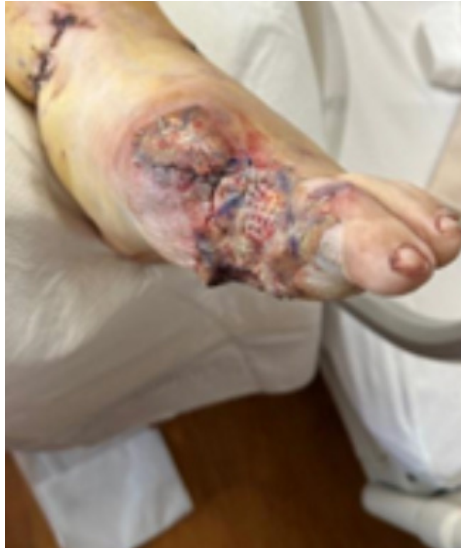
5 days post operative image showed the viable dermis graft and granular tissue forming below the graft.

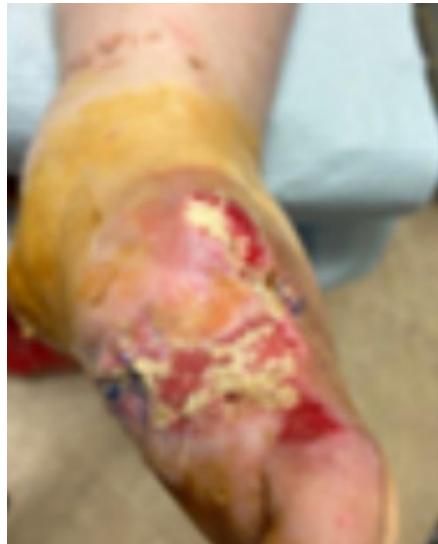
At 2 weeks post-op, progressive granular tissue is noted to be coming through the dermis graft. The post-op x-rays show resorption of some of the CERAMENT G in the 1st metatarsal.

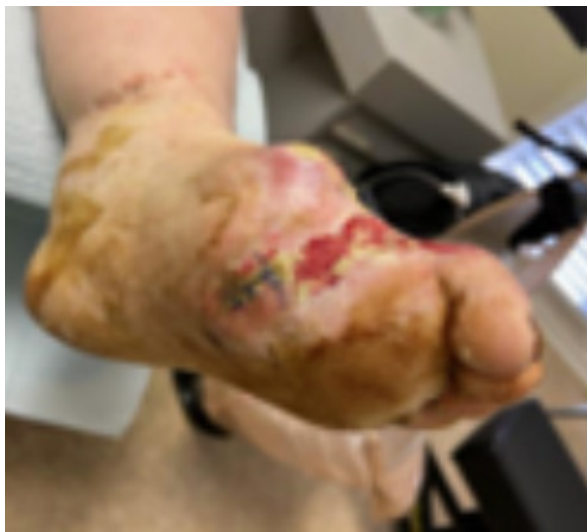
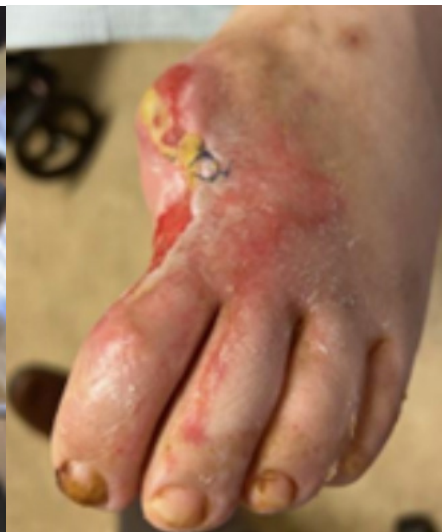
At 1 month post-op, the granular tissue fully grown through the dermis graft.

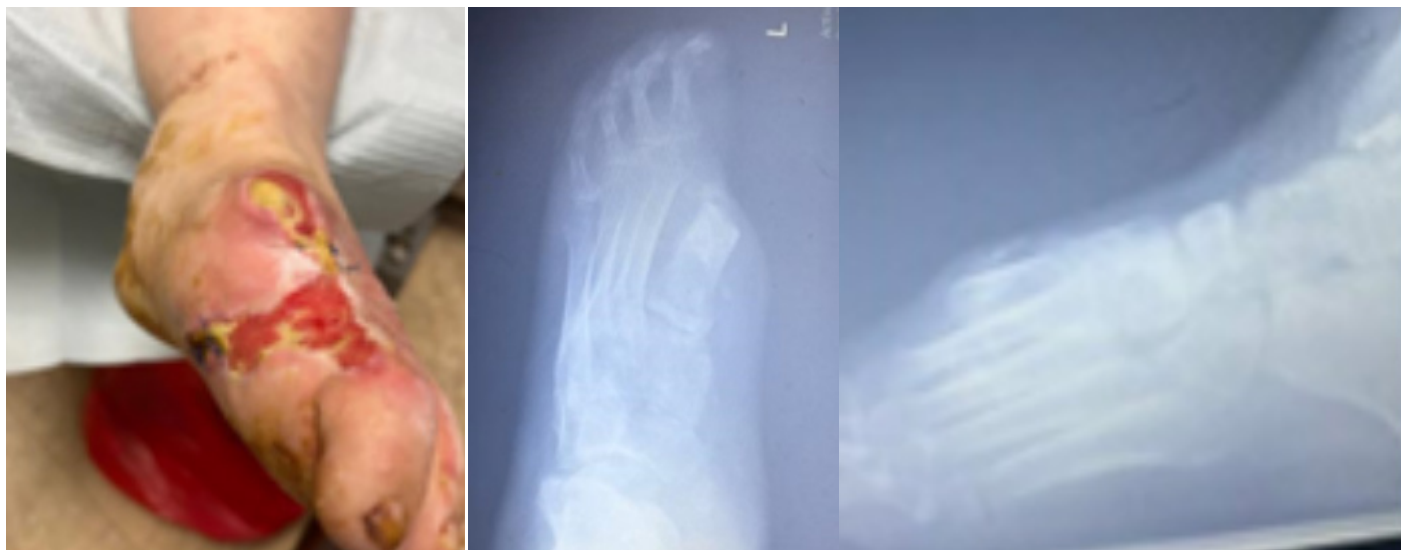
At 2 months post-op, the CERAMENT G is mostly resorbed in the bone and no periostitis or bone erosions are noted; therefore, no evidence of osteomyelitis. The wound continues to slowly heal. Collagen dressings have been used to facilitate healing.

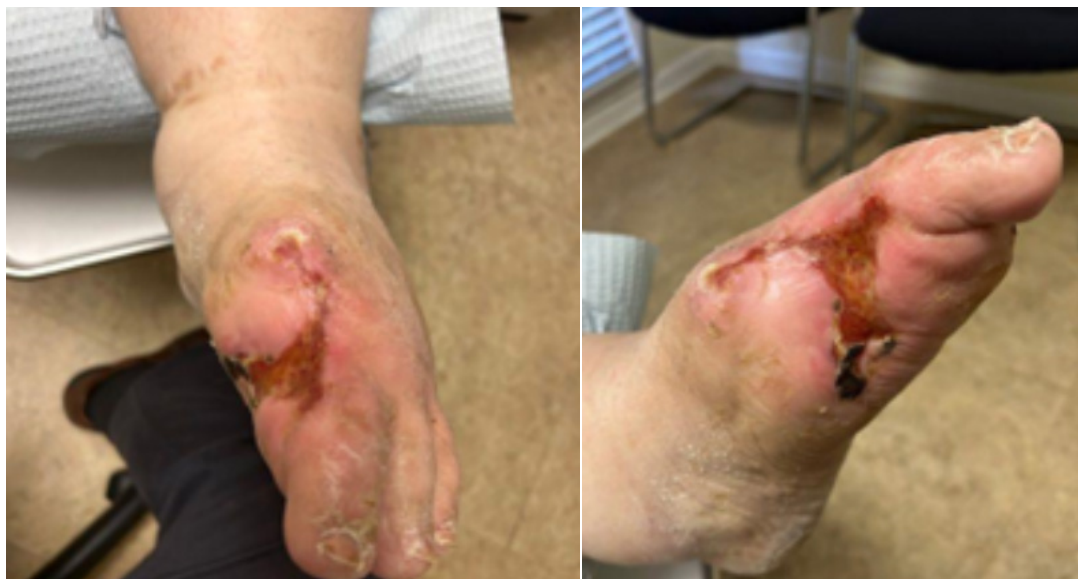
4 month post-op the wound was healing and there was no sign of reinfection.

4 month post-op the wound was healing and there was no sign of reinfection.
